INDOOR AIR QUALITY ASSESSMENT

**Medford High School
489 Winthrop Street
Medford, Massachusetts**

Prepared by:
Massachusetts Department of Public Health
Bureau of Environmental Health Assessment
September, 2001

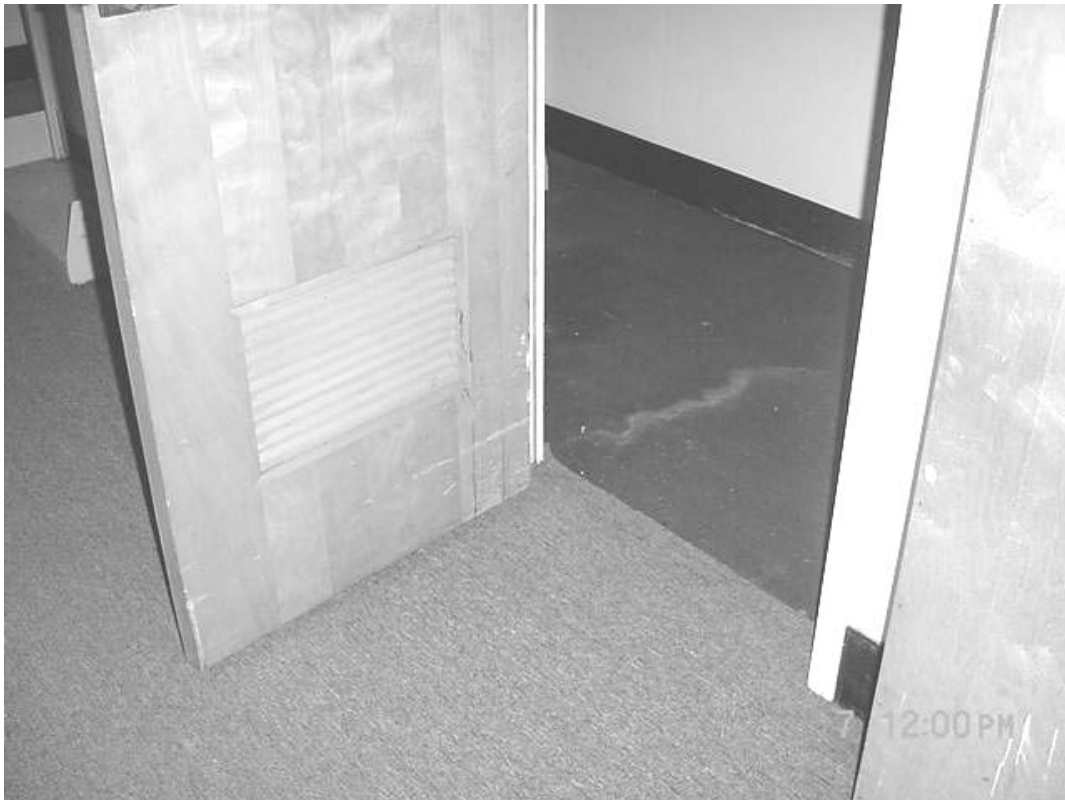
Picture 27

Water Damaged Carpeting in Closet Across From Video Room

13. Examine water-damaged carpeting for mold growth. Discard carpet if moldy. Ensure all carpet remnants and backing materials are removed. Disinfect areas beneath and around carpeting with an appropriate antimicrobial.

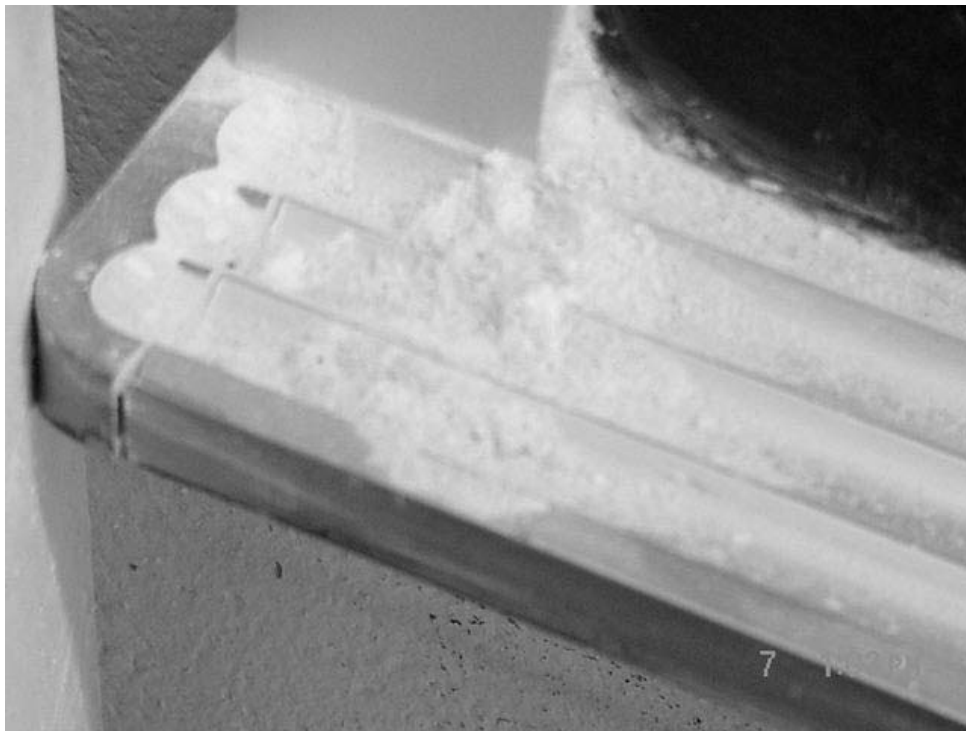
Picture 28

Several classrooms contained dry erase boards and dry erase board markers. Accumulated chalk dust or dry erase board particles were noted in several classrooms (see Picture 28). These materials are fine particulate, which can be easily aerosolized and serve as eye and respiratory irritants. In addition, materials such as dry erase markers and

Accumulated Chalk Dust in Classroom

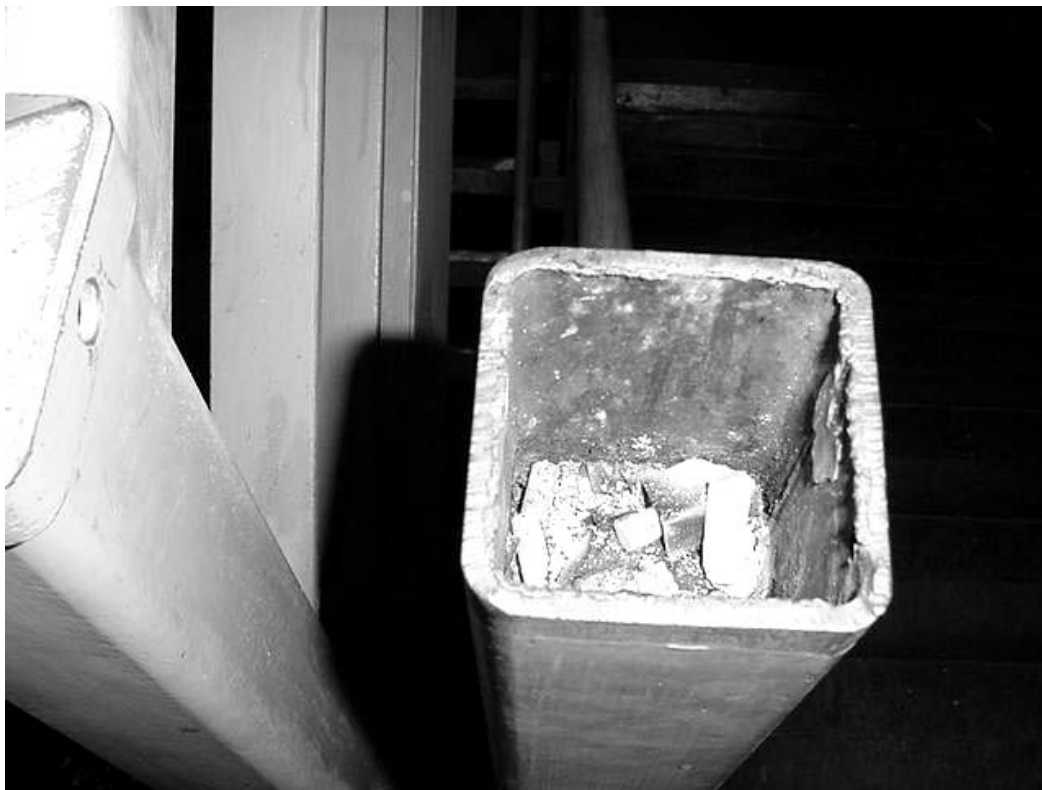
Picture 29

Cigarette butts were observed and the odor of cigarette smoke was noted in several restrooms, the second floor A-wing storeroom and in the B-wing back stairwell (see Pictures 29 & 30). Environmental tobacco smoke can have a marked effect on indoor air quality. Environmental tobacco smoke is an indoor air pollutant, a respiratory irritant and can exacerbate the frequency and severity of symptoms in asthmatics. The most effective method of preventing exposure to environmental tobacco smoke is to have smoke free buildings. M.G.L. Chapter 270, Sec. 22 prohibits smoking in public buildings, except in an area which has been specifically designed as a smoking area (M.G.L., 1987).

Stairwell Support (Cap Removed) Used as Ashtray in B-Wing Rear Stairwell

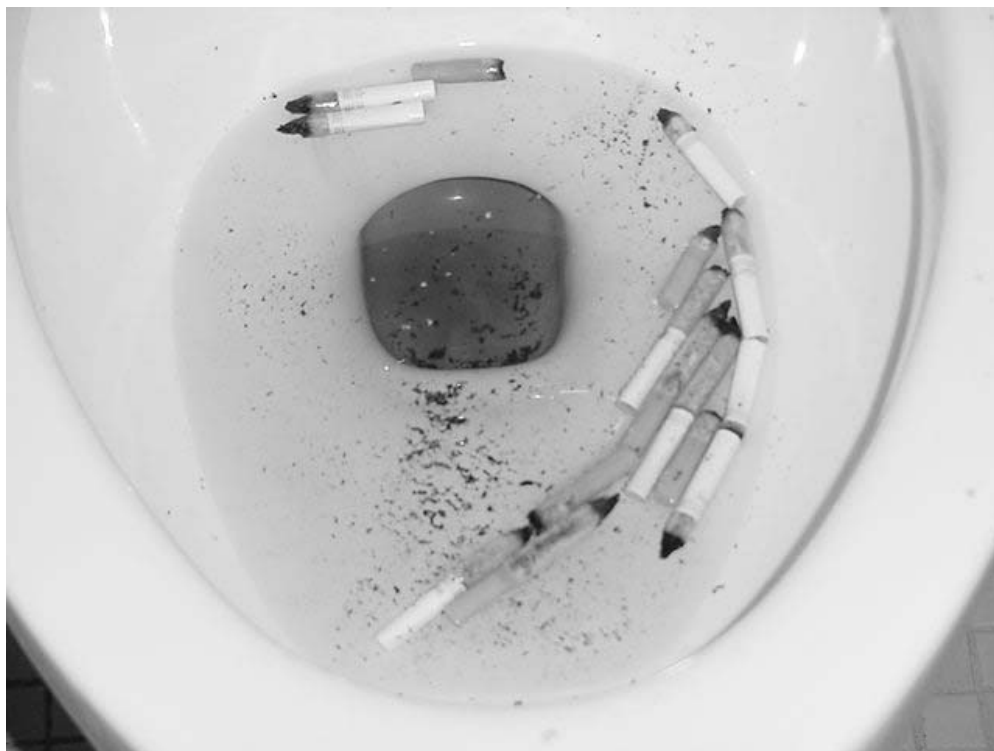
Picture 30

Cigarette Butts in Toilet/Bathroom

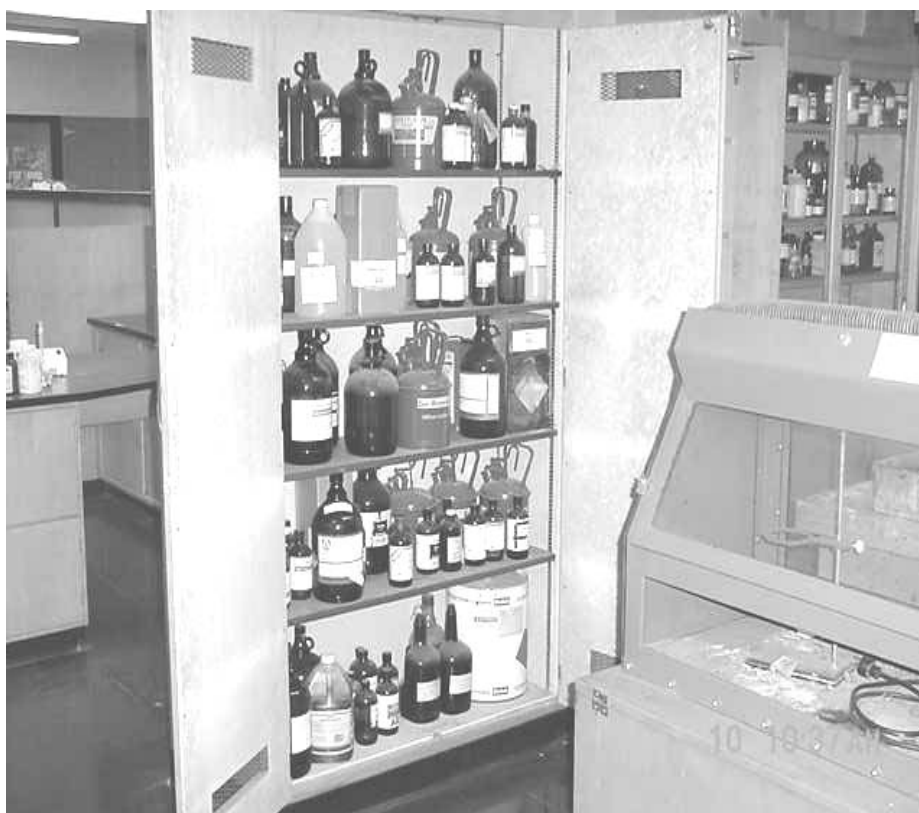
Picture 31

Flammables Storage Cabinet In B-321 Prep Room

15. Replace the B321 cabinet with one that meets the standards set by the National Fire Protection Association (NFPA, 1996) for storage of flammable substances.

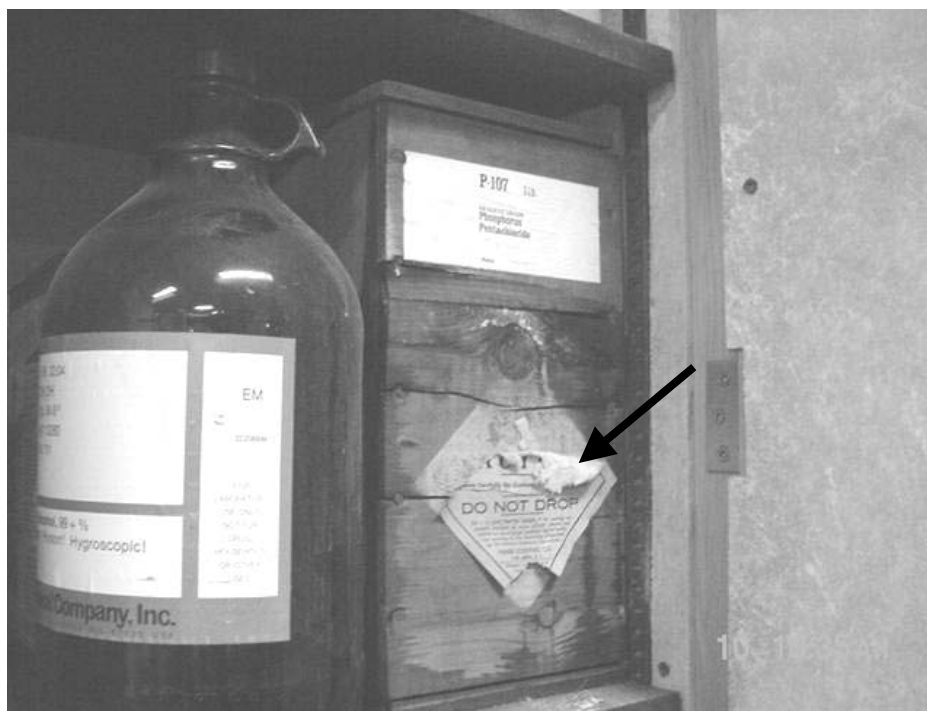
Picture 32

Wooden Box Labeled Phosphorous Pentachloride In Flammables Storage Cabinet In B-321 Prep Room, Note Crystallization On Label

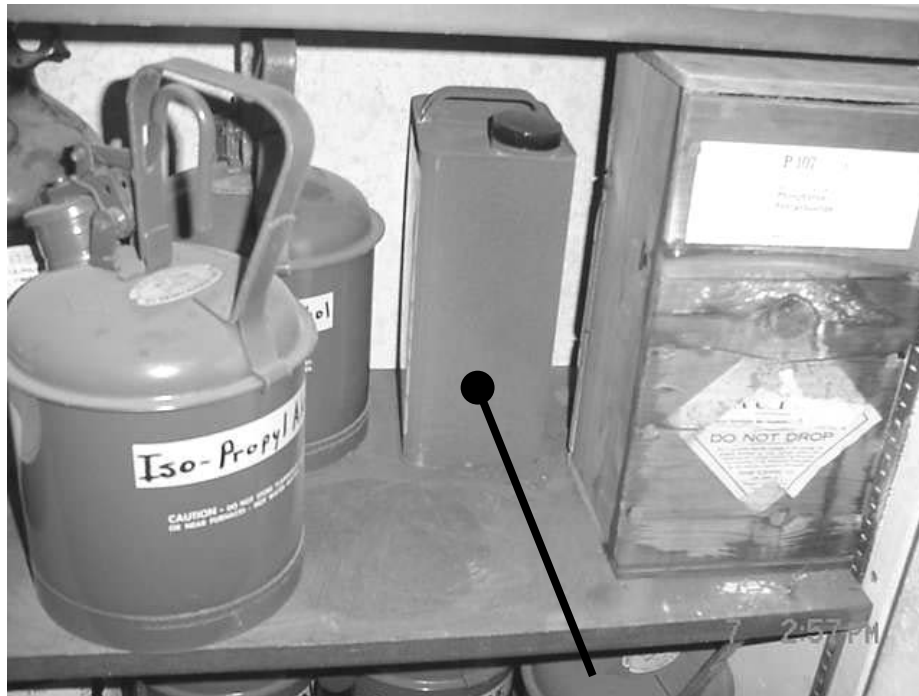
Picture 33

**Metal Container That Is Heavily Corroded in Flammables Storage Cabinet
Flammables Storage Cabinet In B-321 Prep Room
(Container Originally Had Aluminum Finish)**

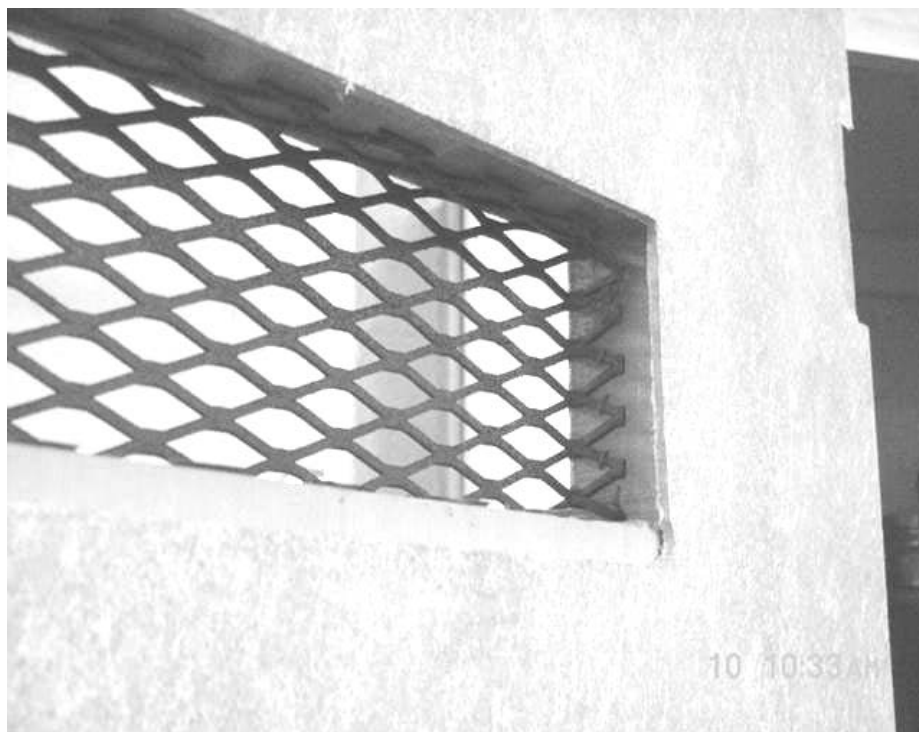
Picture 34

The B-321 storage cabinet appears to be an older vintage, flameproof cabinet. Heavy rust on the passive vents of the cabinet door (see Picture 34), corroded metal of shelf supports and other metal surfaces were observed. This cabinet is not designed to meet the current standards for storing flammable materials set by the National Fire

**Heavy Rust on the Passive Vents of the Door of the Flammables Storage Cabinet
In B-321 Prep Room**

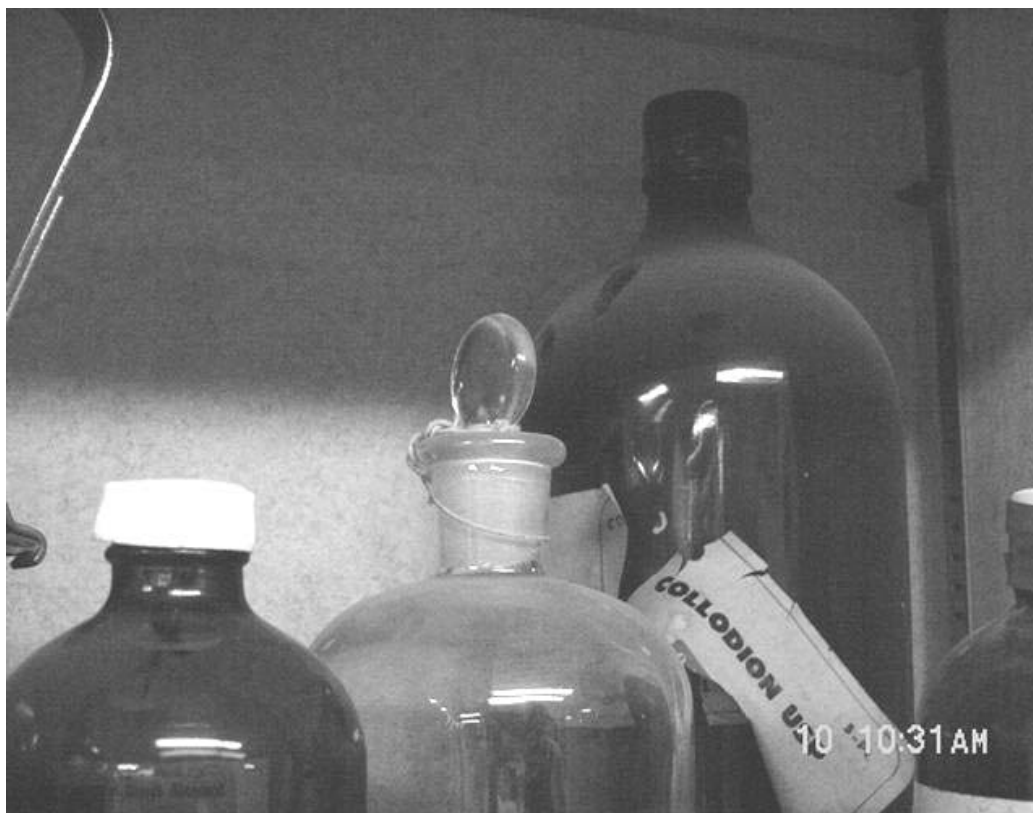
Picture 35

- Storage of metal canisters that can degrade when exposed to organic solvents.
- Flasks containing chemicals that were sealed with glass stoppers held in place with string (see Picture 35) or rubber stoppers. Use of these stoppers can lead to the slow evaporation of materials.
- Bottles filled with chemicals labeled by chemical formula. It is good safety practice to label bottles with chemical name.
- Containers with degraded or missing labels (see Picture 36).
- Containers in cardboard boxes, that can absorb off-gassing chemicals.

Flask Sealed With Glass Stoppers Held In Place With String In The Flammables Storage Cabinet In B-321 Prep Room

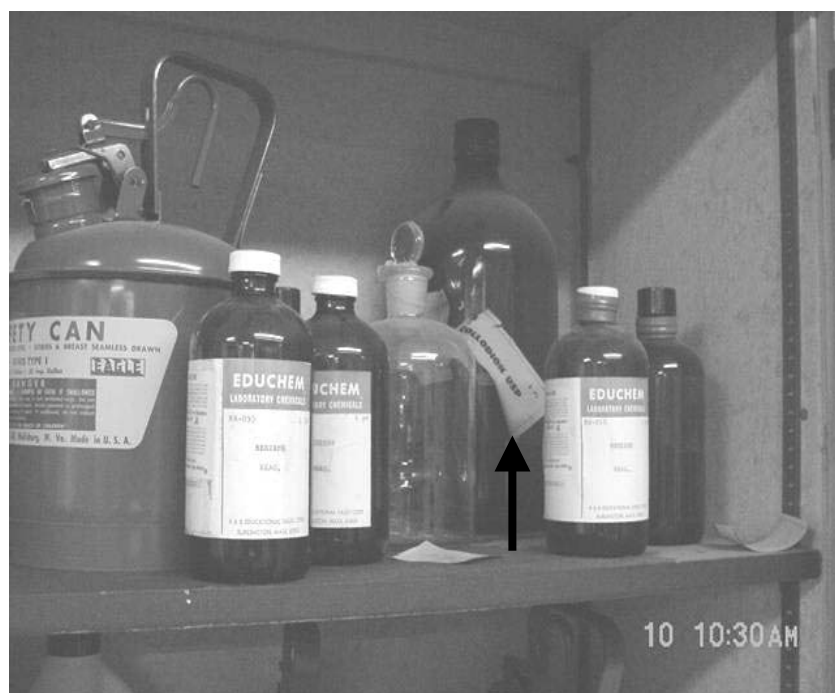
Picture 36

Containers With Degraded Or Missing Labels In The Flammables Storage Cabinet In B-321 Prep Room

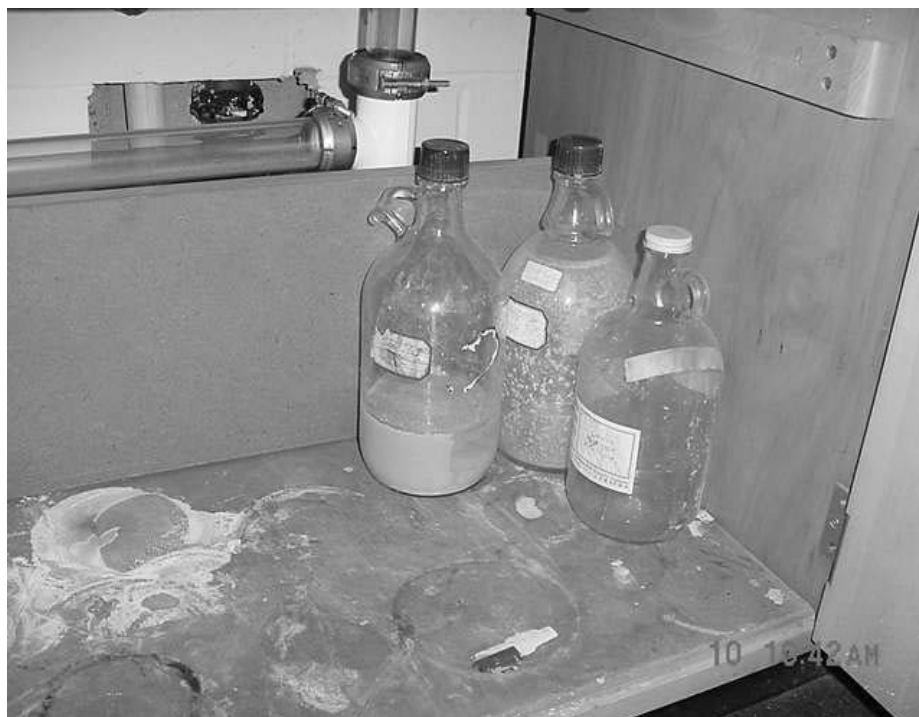
Picture 37

- Three bottles of an unidentified material were stored in a cabinet beneath a sink (see Picture 37). Crystallized materials were noted in these containers.

The Bottles Of An Unidentifiable Material Were Stored In A Cabinet Beneath A Sink In The B-323-Former Dark Room

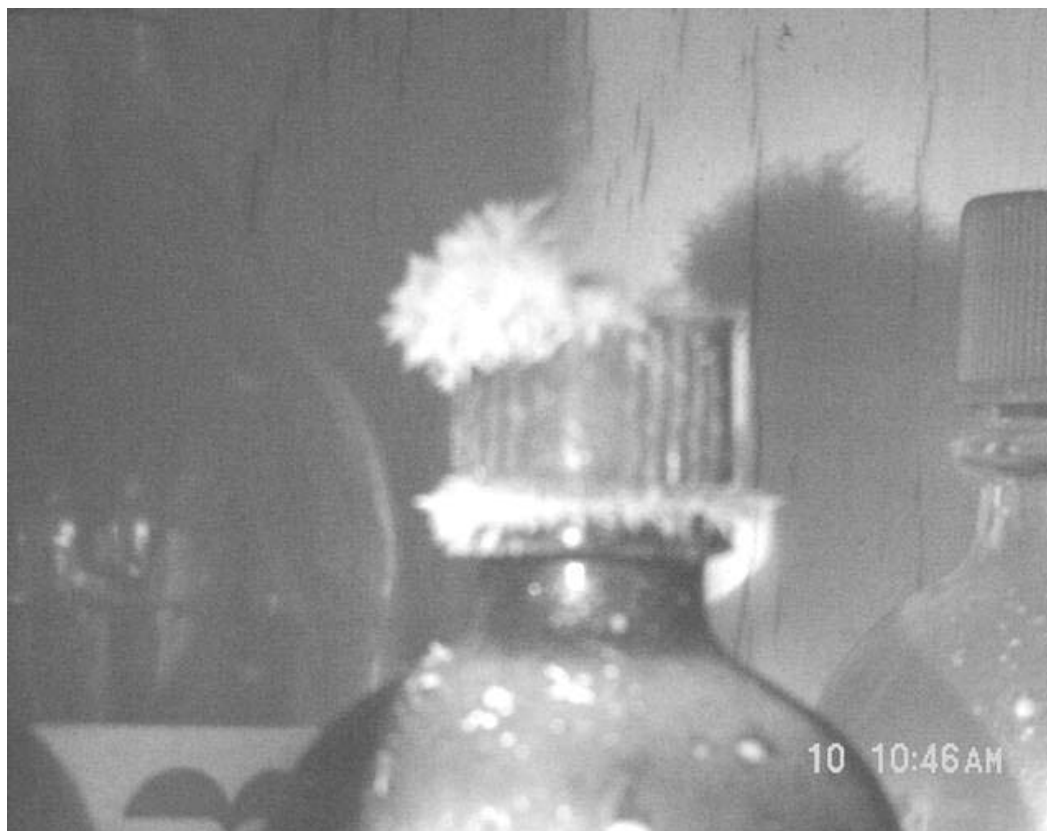
Picture 38

Crystallized Nitric Acid on Bottle Cap in Room B-316

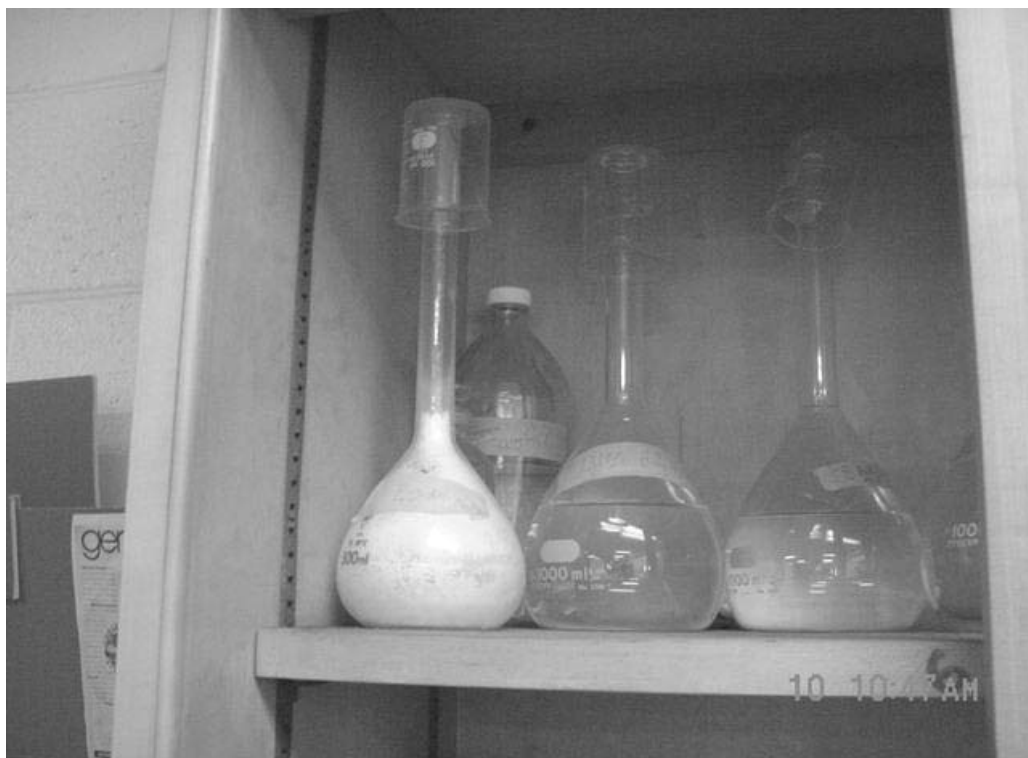
Picture 39

**Containers of Crystallize Sodium Hydroxide Stored with Acids with Containers “Sealed”
With Beakers in B-316**

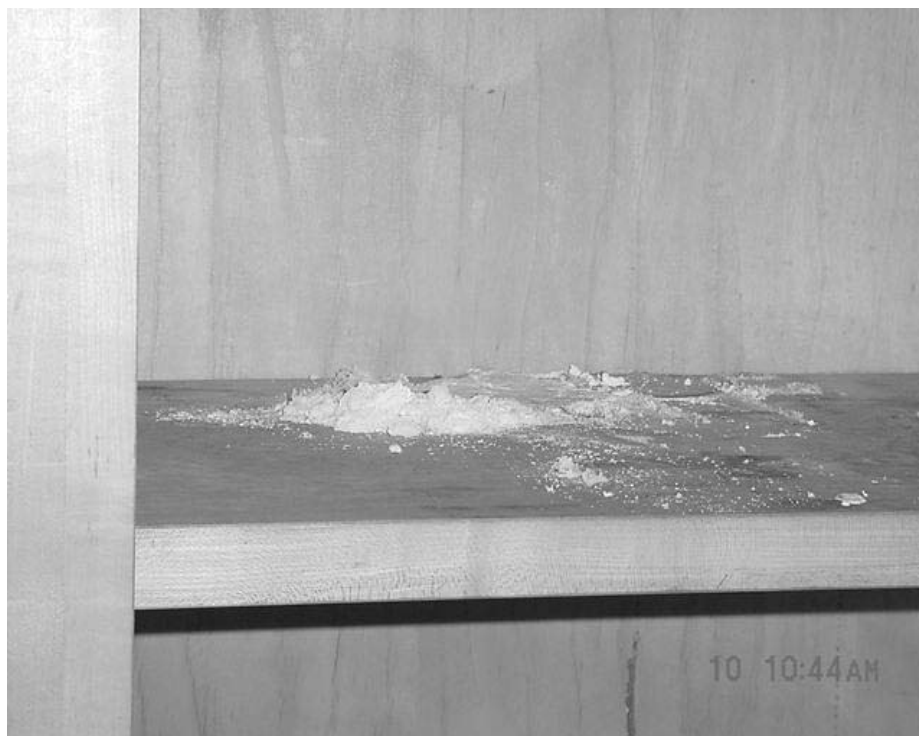
Picture 40

Spilled Powdered Residue of an Unidentified Substance in Cabinet in B-316

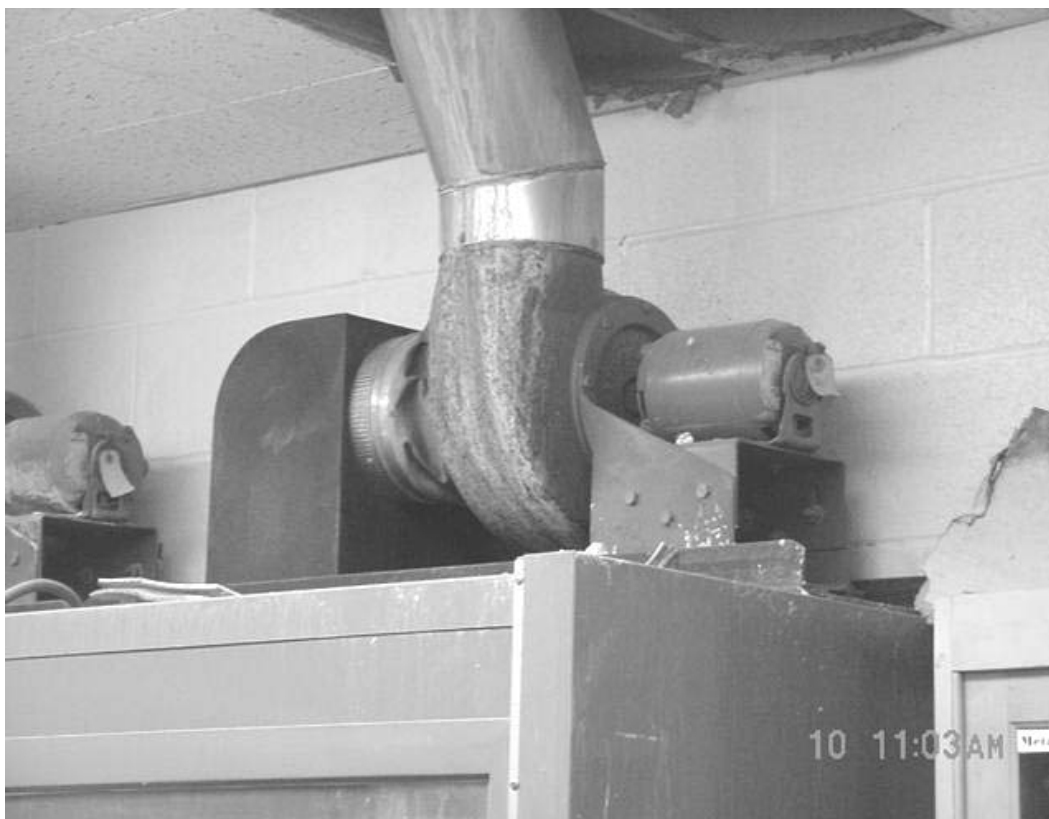
Picture 41

- The ceiling above the “hexane” chemical hood is heavily water damaged (see Picture 41). It was not determined if this water damage has led to degradation of hood operation and/or has created breaches in the cabinet via corrosion.

Ceiling Above the “Hexane” Chemical Hood in B-314

16. Obtain an acid resistant cabinet for storage of acids.
 17. Operate chemical hood exhaust fans at all times that chemicals are present within the equipment. Do not use chemical hoods for storage of chemicals. Examine the integrity of chemical hood cabinets and ductwork that is water damaged.

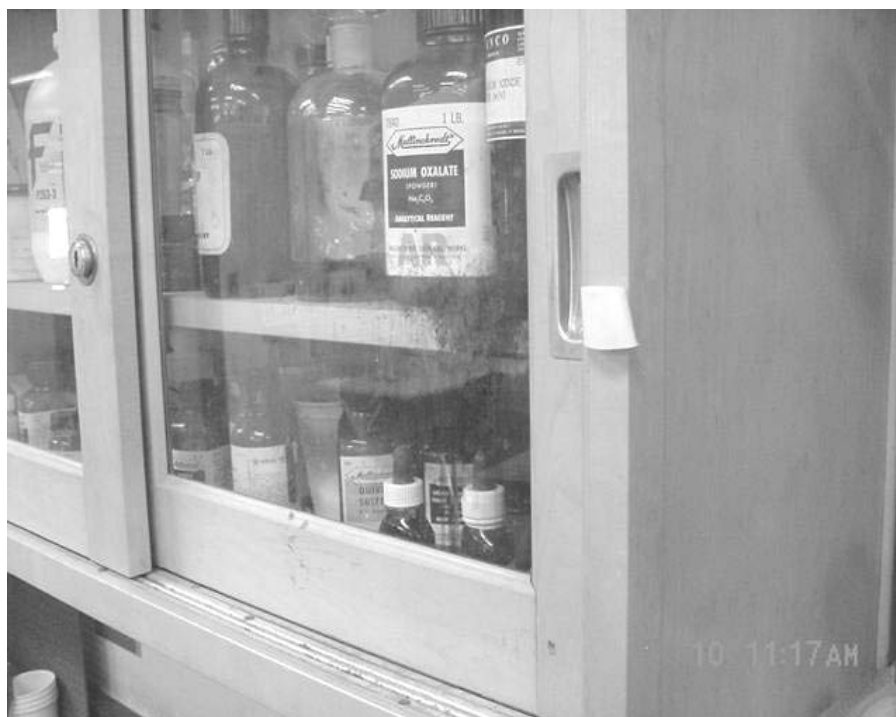
Picture 42

- Glass of a cabinet was stained with an unidentified black material (see Picture 42). This material should be removed as a hazardous waste. Also noted were stored bottles of hydrochloric acid that have signs of crystallization on containers.

Glass of Cabinet Is Stained With A Black Material in B312

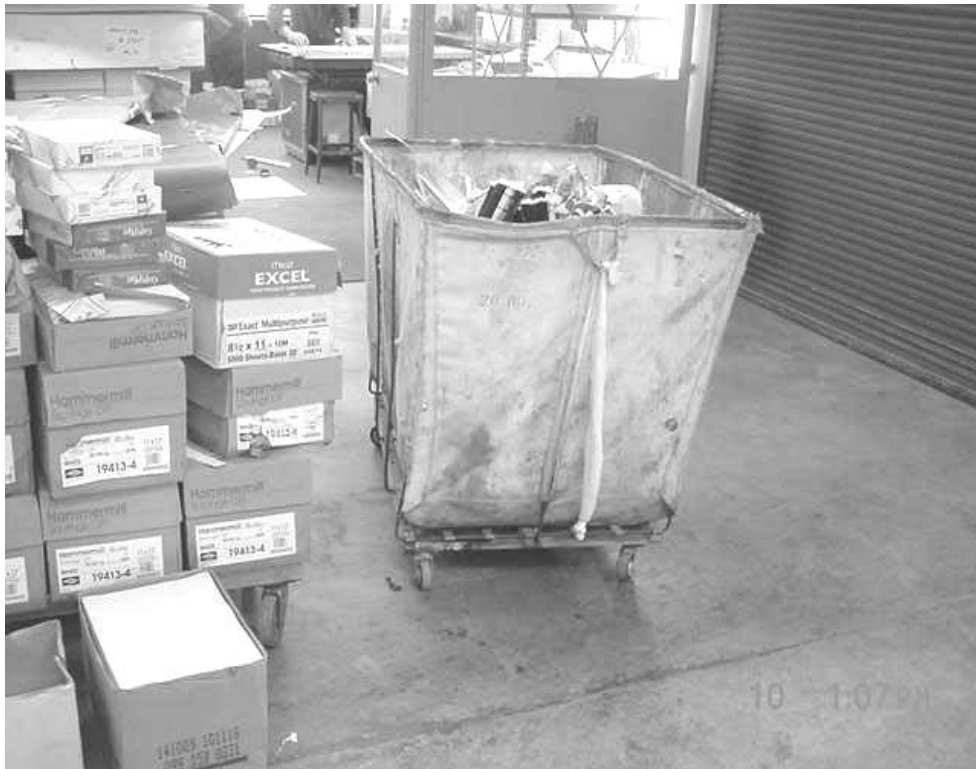
Picture 43

A Large Canvas Laundry Hamper Is Used To Collect Various Print Shop Wastes
